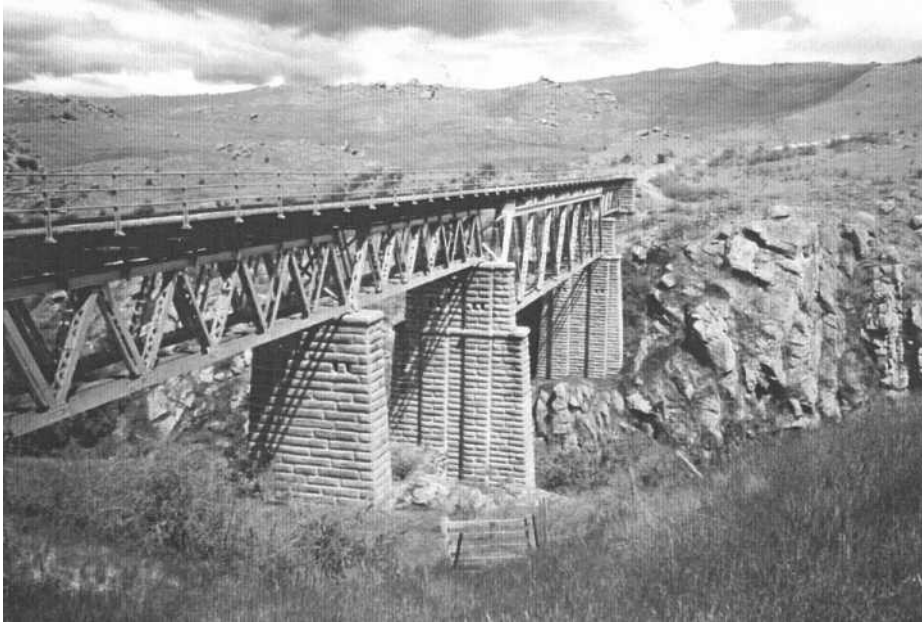
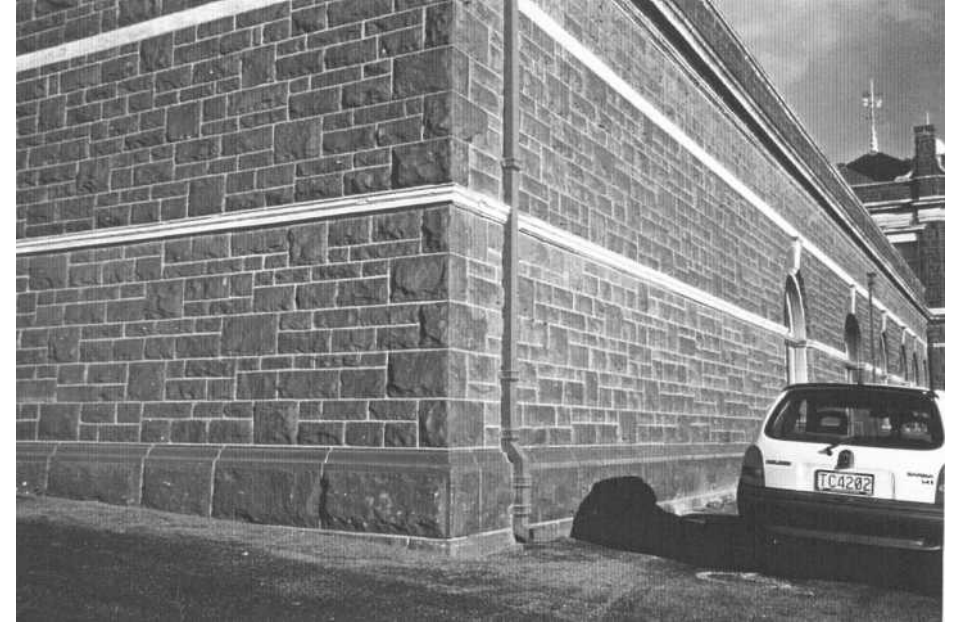
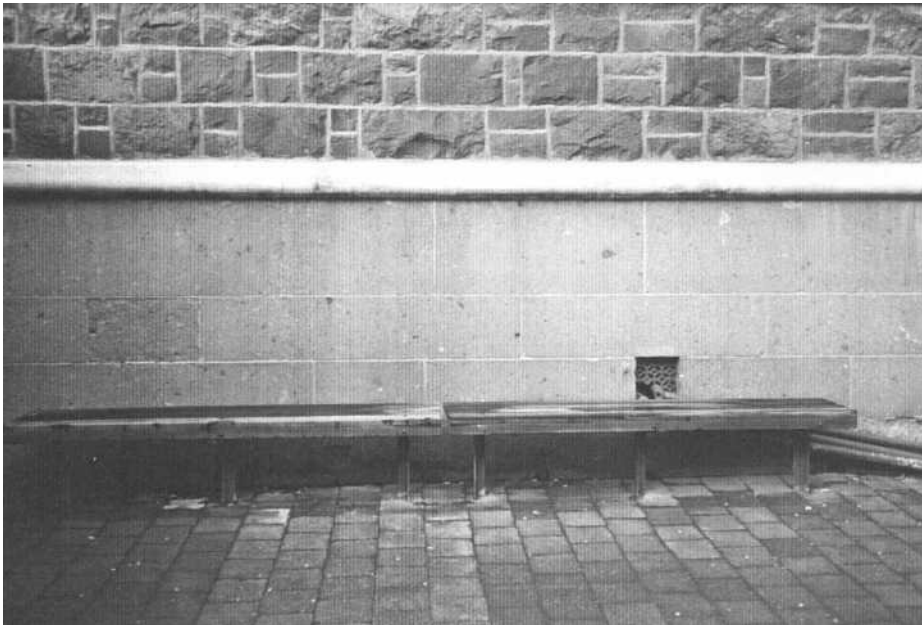
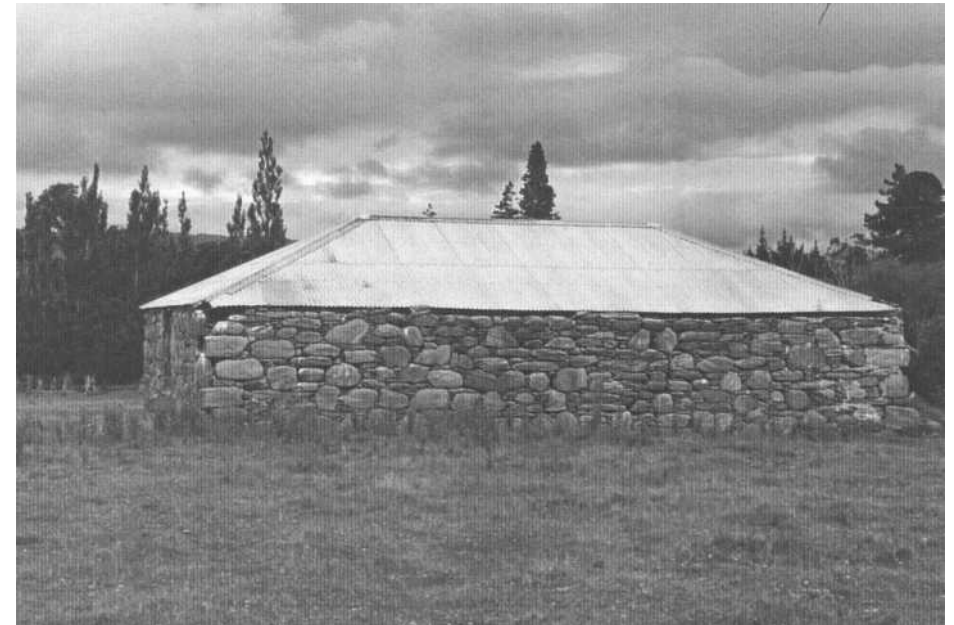
Figure 2 Examples of masonry - wholly, partly and not brought to course.
Top left: the schist masonry abutments of the Poolburn viaduct fully brought to course
Top right: the basalt masonry of the Dunedin railway station partly brought to course.
Bottom left: the Geology building, University of Otago, with a sandstone foundation brought to course and basalt wall partly brought to course.
Bottom right: the shearers' quarters at Taieri Lake station rubble built and not brought to course.

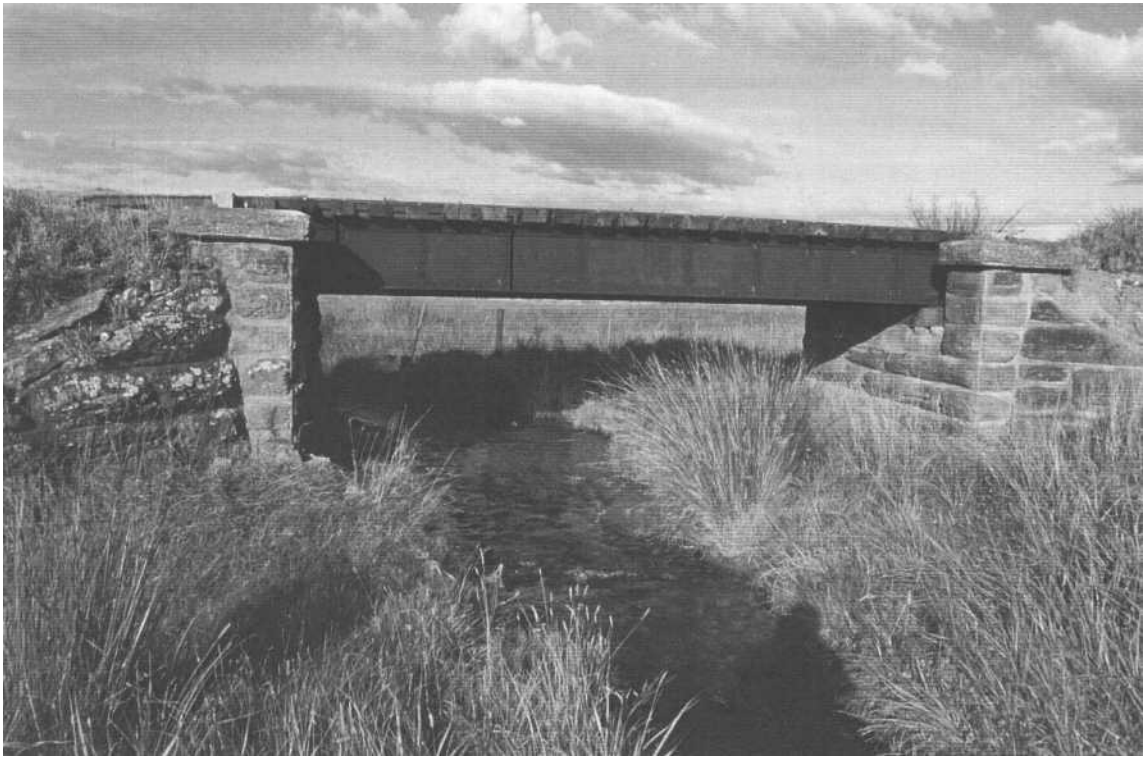
Figure 3 Two modest bridges on the Strath Taieri, with fully brought to course schist abutments on the line north of Pugh Road, Bridge 41 above and Bridge 40 below.
