5.3 Salt marsh retreat

6. CONCLUSIONS

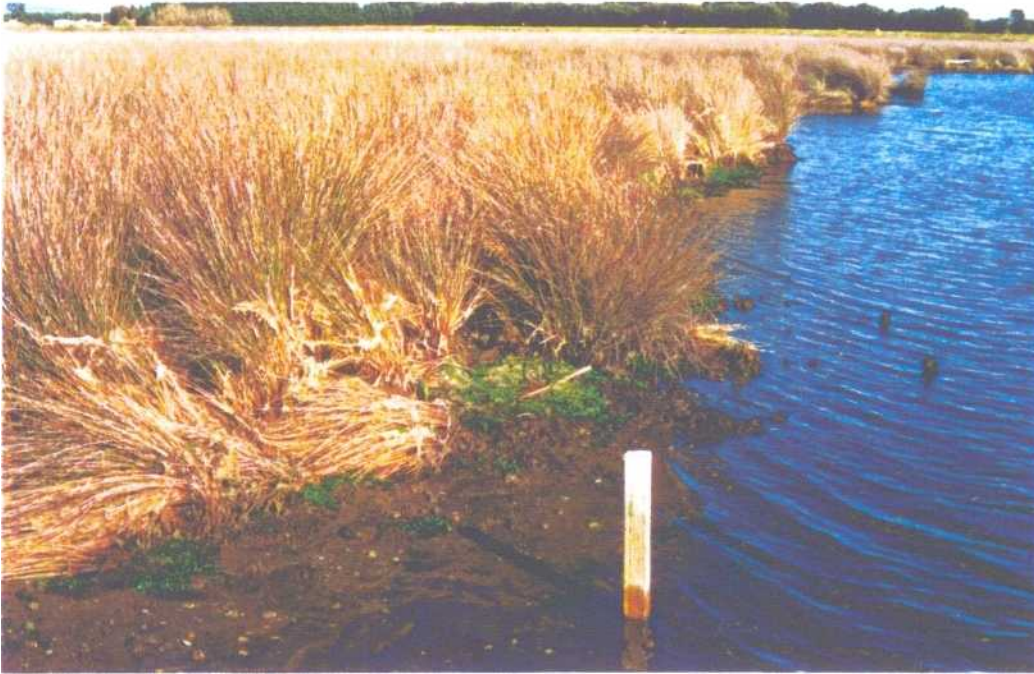
Plate 3: On the exposed seaward side of the salt marsh remnant, the margin of the vegetation has continued to retreat at a significant rate (0.7-1.5 m over 4 years). This datum peg was placed 4 years earlier at the edge of the vegetation but wave action and other factors during this period has resulted in the vegetation retreating by over 1 m. Parts of the original soil horizon are also evidence of the salt marsh retreat.

On the seaward side of the remnant, salt marsh vegetation has continued to retreat generally toward the east. Of the 14 datum pegs remeasured nearly 4 years after they were positioned around the edges of the remnant, 11 indicate that the vegetation has retreated from 70 cm to 1.5 m (Plate 3). The level of the substrate has decreased by 10 cm (Plate 4). However, at one inland site, there was expansion of the salt marsh vegetation by 60 cm.

Clearly, the salt marsh remnant at Maketu Estuary is still retreating at a significant rate. If at least 1 m of erosion of vegetation occurs each year along exposed margins, then the present remnant is likely to be reduced to discontinuous patches of salt marsh vegetation within 50 years and to disappear within a century.

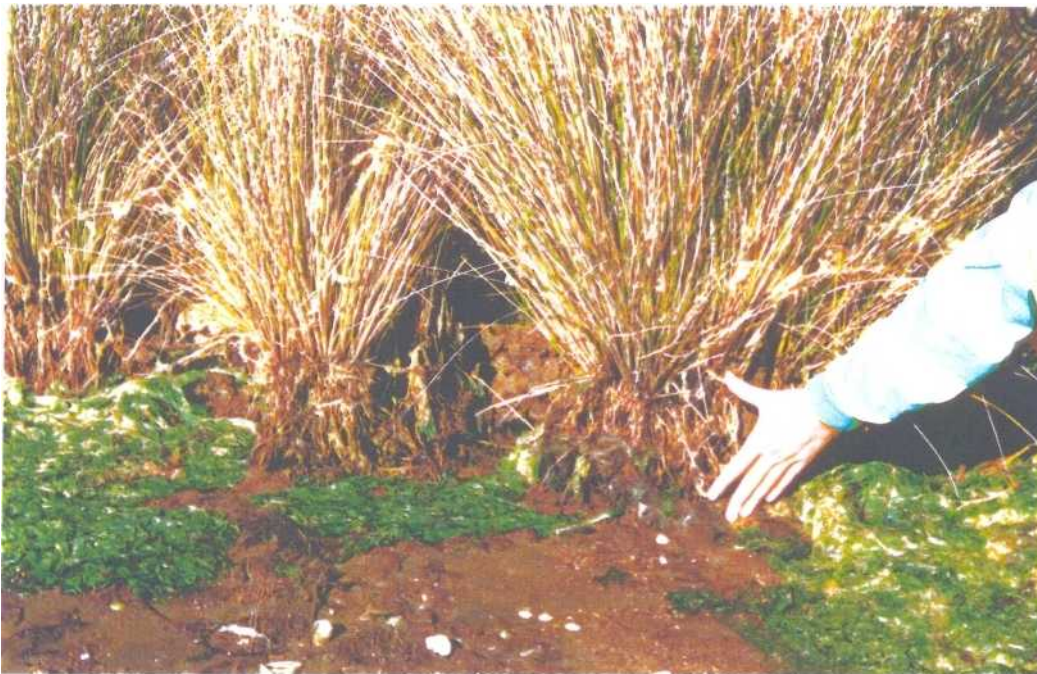
Plate 4: The level of the estuary has decreased around parts of the salt marsh remnant by 10 cm over the last 4 years. Consequently, edge plants particularly on the exposed side of the remnant are undermined by wave action, exposing root systems, and plants are washed out resulting in loss of salt marsh vegetation.

The abrupt differences in levels between the salt marsh and the lower adjacent mudflat remains a significant feature. Suggestions that decline of the salt marsh is the result of the reducing elevation of the area, exposing marginal vegetation root systems to constant wave abrasion, and a possible link to the diversion of the Kaituna River nearly 40 years ago is discussed in Bergin (1991).

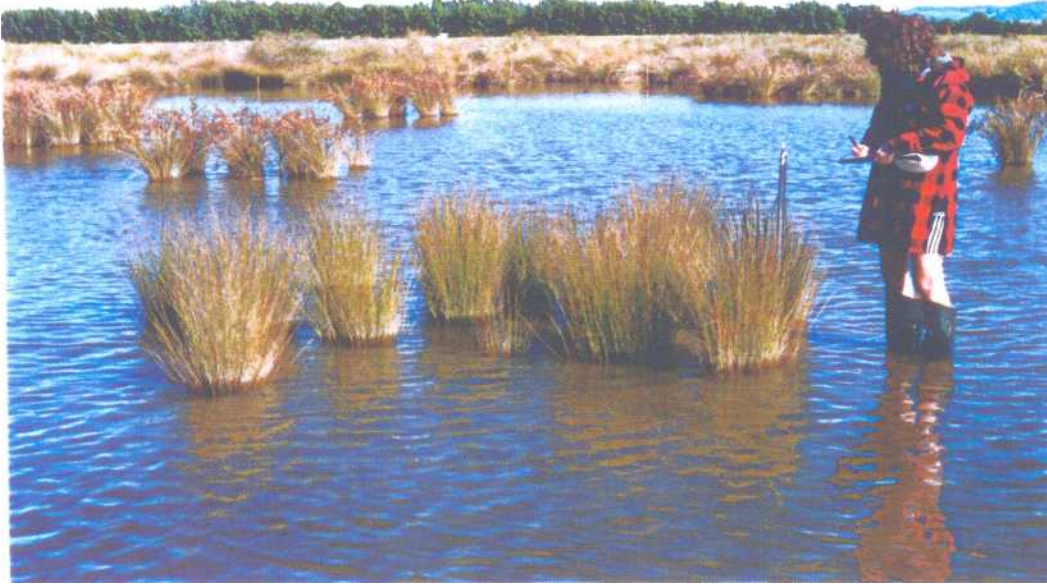
Plate 5: Large clumps of *Leptocarpus similis* have not expanded as fast as *Juncus maritimus*. It will be at least a further year before this medium-spaced cluster (planted 70 cm apart 4 years earlier) of *L. similis* will have a closed canopy.

The low survival of medium and small clump-sizes of *L. similis* indicate that large clump-size is the only option for successful establishment of this species. Unfortunately, plant spacing was not tested with this species with all plots planted at only medium spacing (70 cm apart). It is likely to be a further year or more before even the larger *L. similis* transplants coalesce into uniform salt marsh vegetation (Plate 5). However, in a pilot planting of *L. similis* established a few months before the main transplanting trial was established, a dense uniform stand has formed indicating that although it is slower to expand than *J. maritimus*, *L. similis* will eventually occupy the site (Plate 6). All transplants in the pilot trial were equivalent to the large clump-size and were planted at the close spacing of 4 plants/m² (plants 50 cm apart).

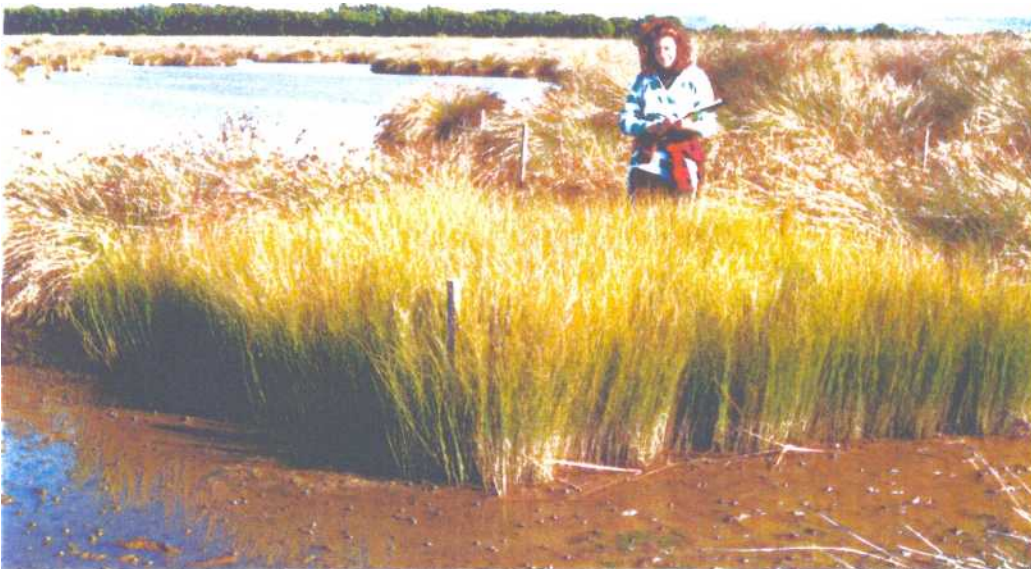
Plate 6: *Leptocarpus similis* established in a pilot trial has expanded in 4 years to fully occupy the site. Large clumps (100 x 100 x 150 mm depth) were transplanted at close spacing (50 cm apart). Although not tested in the main trial, the pilot trial does indicate that large clump-size and close plant spacing is the preferred option for this species. Growth of *L. similis* is not as fast as *Juncus maritimus*.

Where large scale transplanting is considered and resources are limited, medium-size clumps should be planted at wide spacing, with some mortality inevitable. However, where resources are sufficient, including adequate labour and a nearby source of healthy transplant material, and rapid revegetation of mudflats is desirable, the best option is to plant large transplants (100 x 100 x 150 mm depth) at close spacing (50 cm between plants).
